Characterization of Microwave Generating Vacuum Tubes

This is a performance report on several Extended Interaction Oscillators (EIOs) and Carcinotrons in the Polarized Target Lab. In total, there were 5 EIOs oscillating around 140 GHz, 2 EIOs oscillating around 180 GHz, and 3 Carcinotrons oscillating around 70 GHz. Before testing, the tubes had to be setup in working order. Each operating range requires its own setup, which will be explained in their corresponding sections.

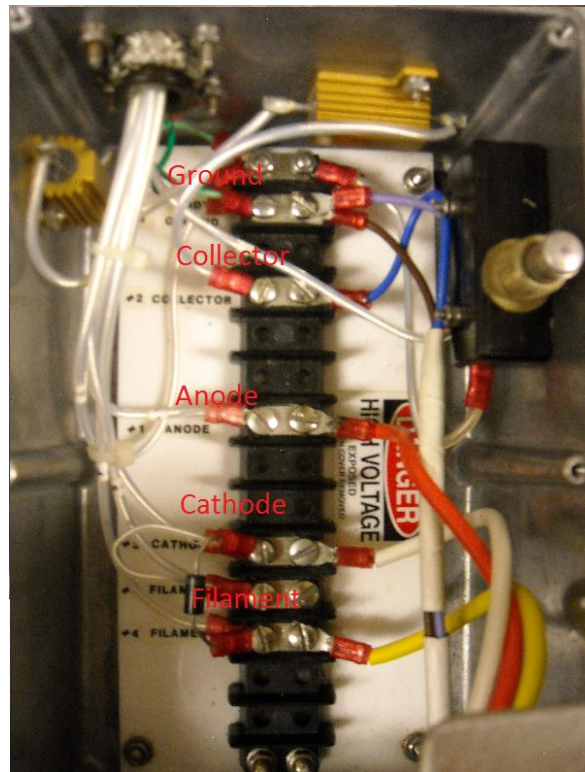
The EIOs operating at 140 GHz were tested first. The EIO is connected to the power supply following a color code

Color	Purple + Brown	Blue	Red	White	Yellow
Connection	Ground	Collector	Anode	Cathode	Filament

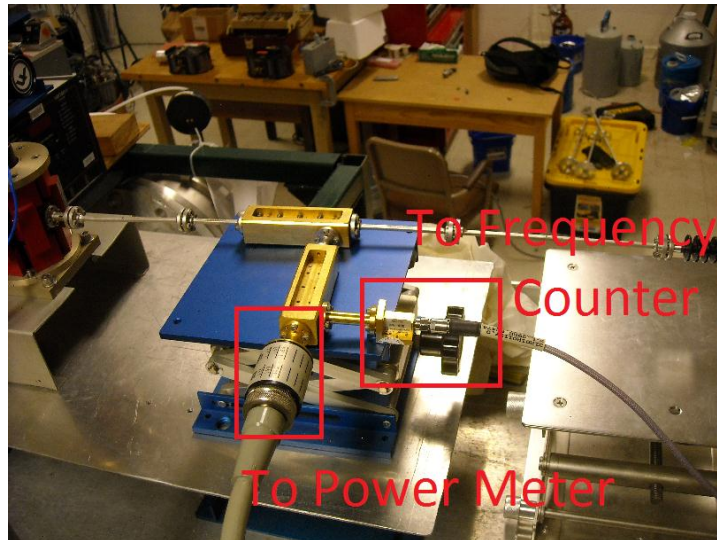
The target setup is shown in the image below.

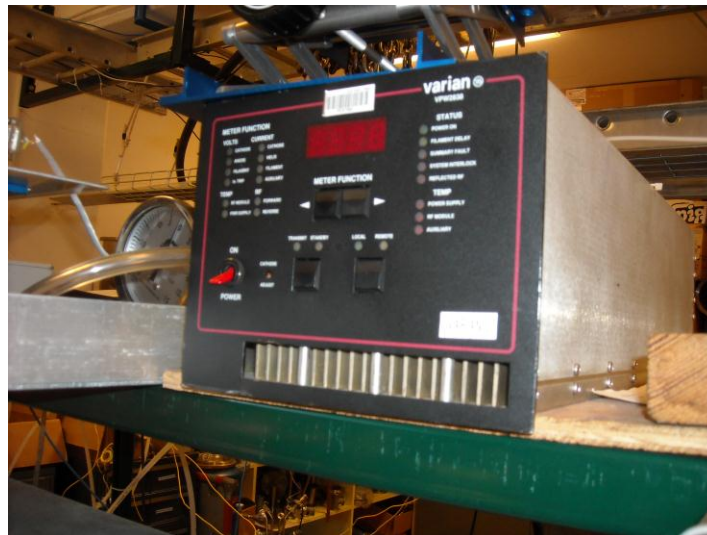
Power Supply for 140 and 180 GHz EIO's

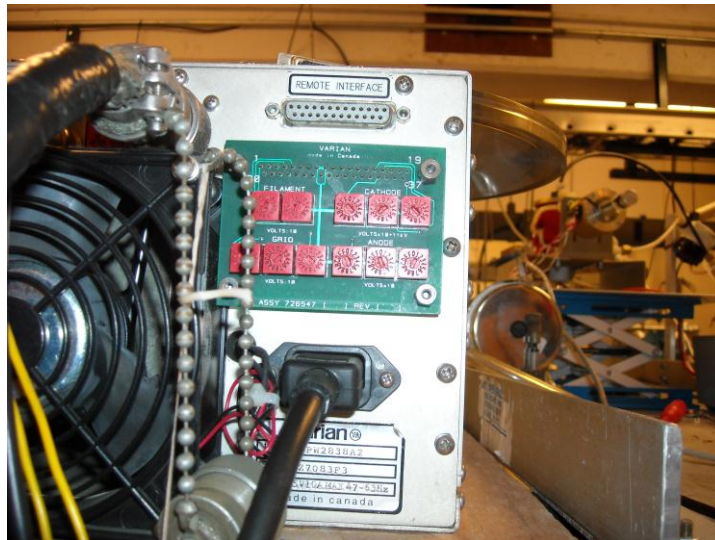
Adjust testing parameters from back panel

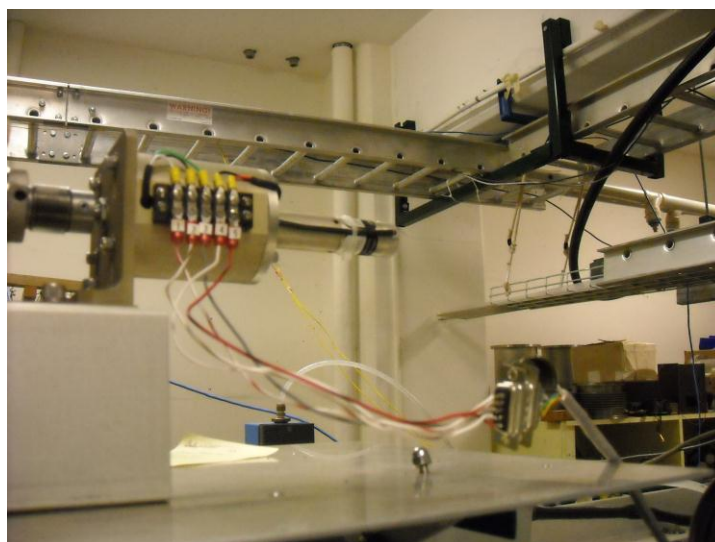
Bellows Position

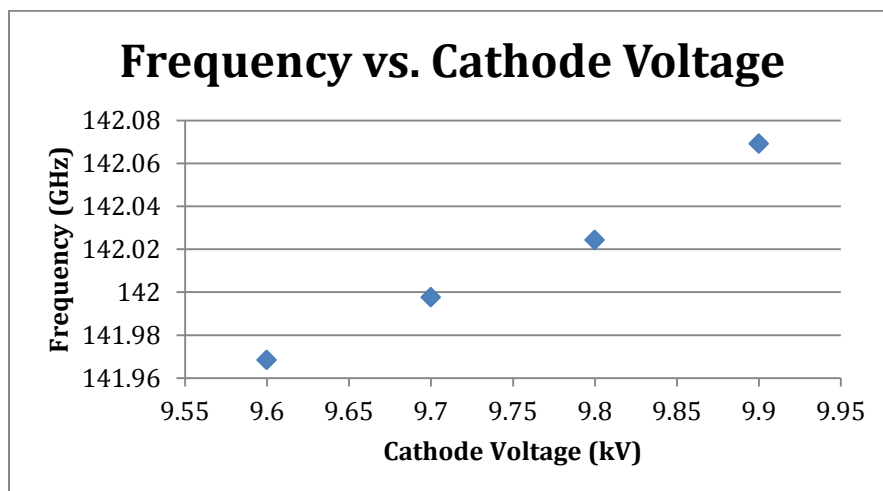
The testing parameters were set according to the same conditions recorded in previous tests. These parameters are recorded in each respective spreadsheet. For each EIO, the Frequency was measured as a function of Cathode Voltage as well as Bellows Position (when applicable). The result is that frequency increases linearly as a function of Cathode Voltage for a constant bellows position.

Result for EIO #EO638J2 for constant Bellow Position 5.448

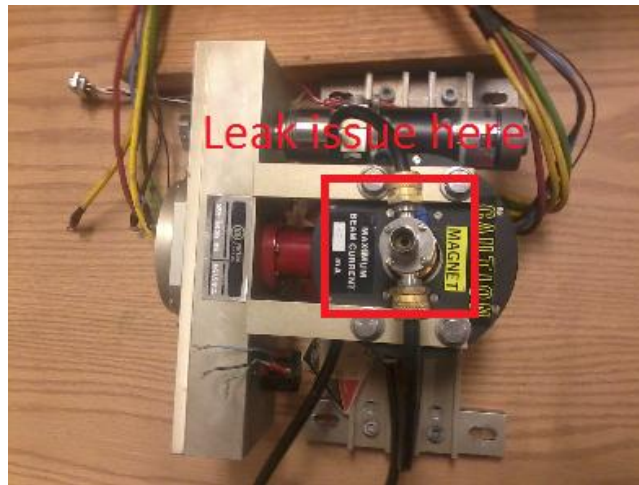
EO199C0 Leak Issue

EIO #	Result
EO638J2	Operates fine. Oscillates around 140 GHz
EO735M4	Oscillates around 141 GHz. Contains pockets at certain bellows position where the tube loses power
EO738G5	Operates around 140 GHz. Minor leak issue
EO199C0	Major leak problem – unable to test. Previous tests show oscillating range around 137 GHz
EO104J8	Doesn't work. No Previous test data available

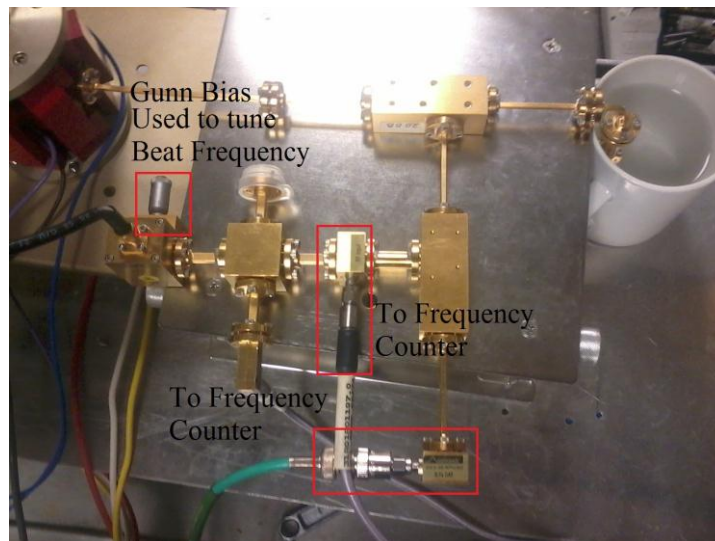
The EIOs operating at 180 GHz were tested next. The color code for the connections to the power supply remains the same. The target setup is shown in the image below.

The two frequency counters are used to determine the output frequency of the EIO. One counter measures the RF Frequency which is ~90 GHz. The other counter measures the beat frequency, which must be tuned to the order of ~1 GHz using the Gunn Bias. This occurs at about 2.40. The output frequency is then $(2 \times [\text{RF Frequency}]) + [\text{Beat Frequency}]$, which is around 180 GHz. There is no Bellows position for the 180 GHz EIOs. Once again, the output frequency was measured as a function of the cathode voltage. The data shows a linear relationship.

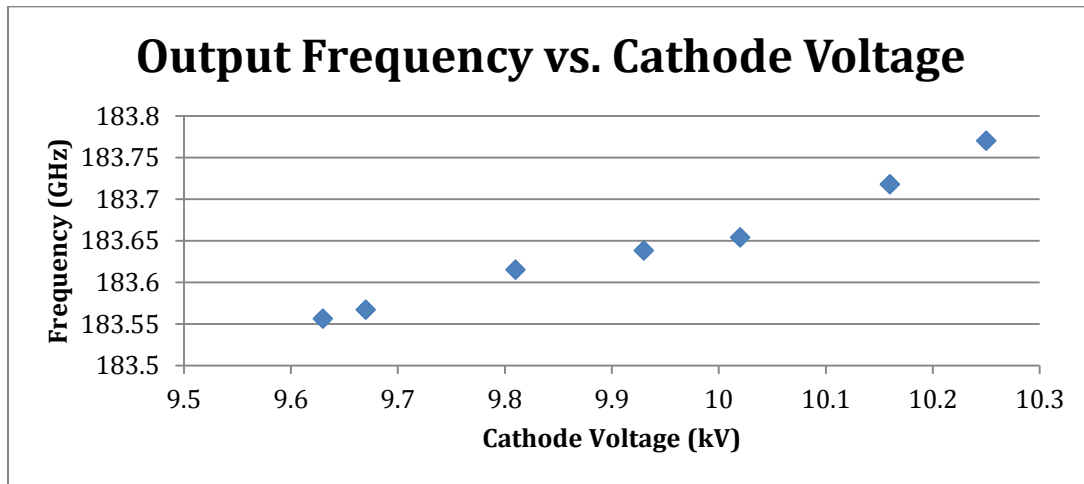
Result for EIO #EO951F3

Both EIOs worked very well without any issues.

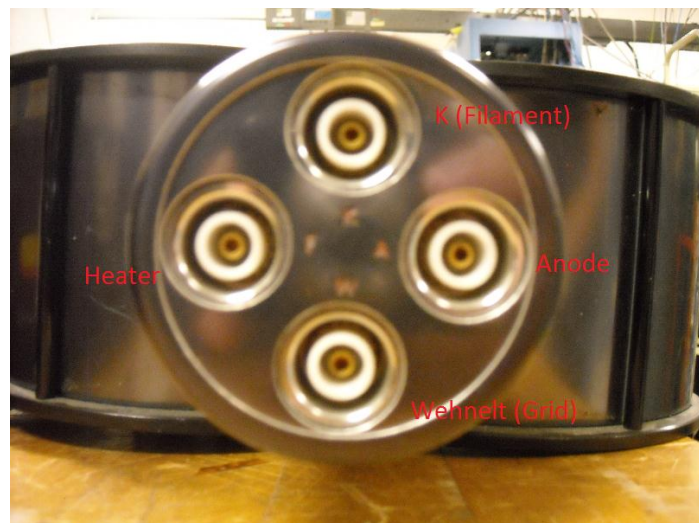
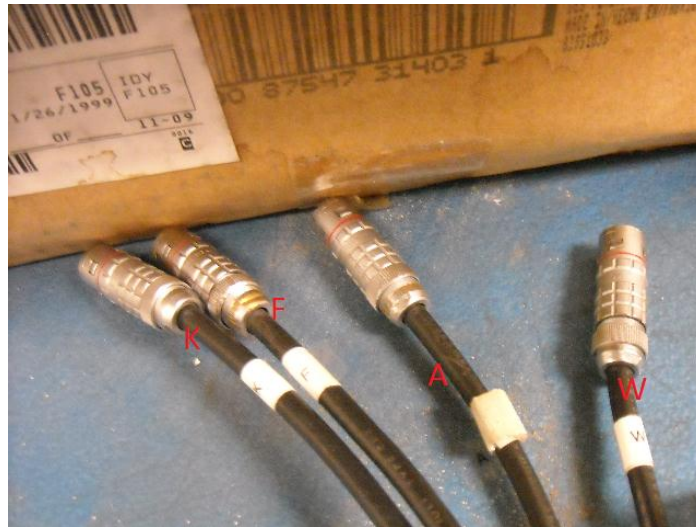
The final tests were the 70 GHz Carcinotrons, which use a separate power supply. They are connected to the power supply using four cables in a compass configuration where the Filament (labeled K) is North, the Anode is East, the Grid (labeled Wehnelt) is South, and the Heater is West.

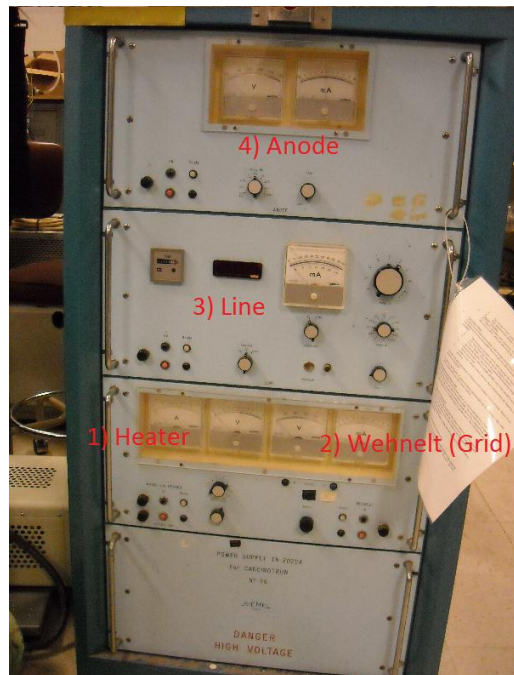
A specific set of instructions must be followed in order to turn on the power supply.

1. Turn on the Heater and set the current to the appropriate value
2. After 5 minutes, turn on the Grid and set the voltage to the appropriate value
3. Turn on the Line and set it to the minimum testing value (typically around 3 kV)
4. Turn on the Anode and set to the appropriate value

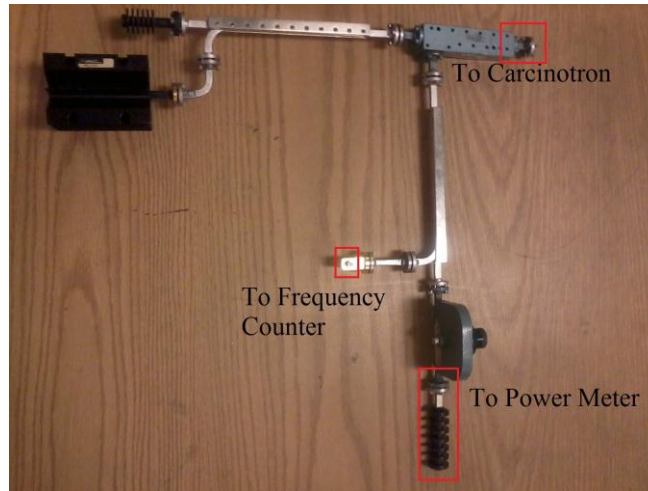
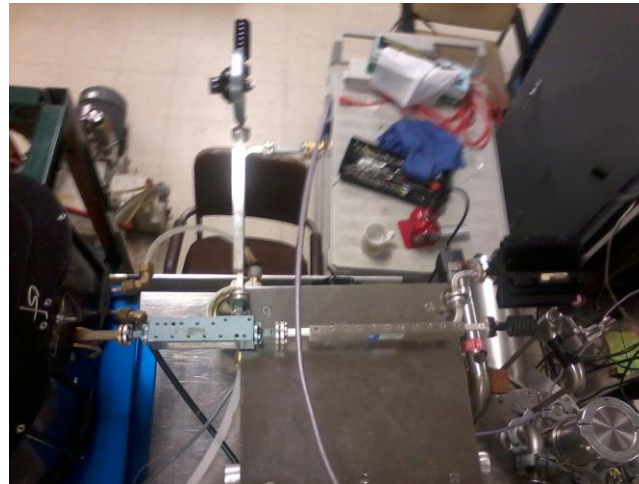
The Carcinotron should be set up with the following attachment.

Normally, a power meter is attached, but we were unable to find the right transition piece between the different band sizes.

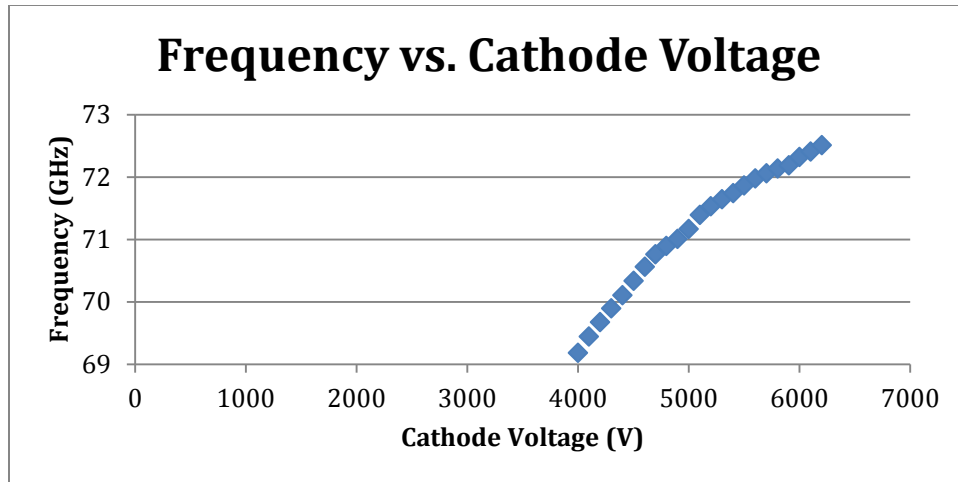
The test shows that frequency increases nearly linearly as a function of cathode voltage for lower values, with the rate of change slowly decreasing.

Test result for Carcinotron #351-01

Carcinotron #	Result
239-5	Settings not optimal. Frequency counter often loses reading
351-01	Major leak issue fixed after replacing all of the tubing
234-1	Works as expected
